Municipality of Anchorage Geotechnical Advisory Commission

Response to 30 Nov 2018 Earthquake

GAC'S RESPONSE TO THE 30 NOVEMBER EARTHQUAKE

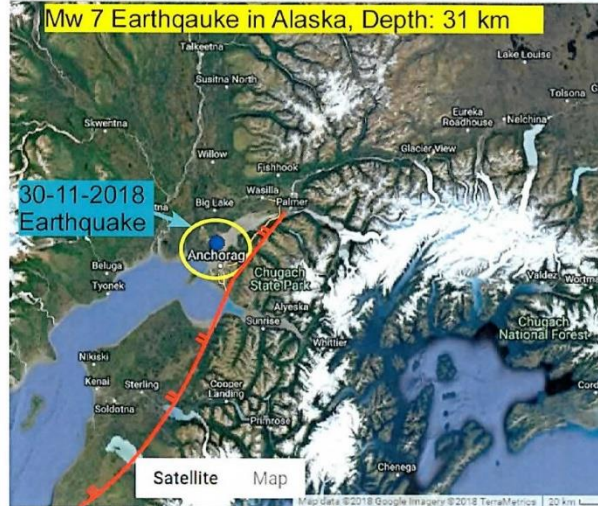
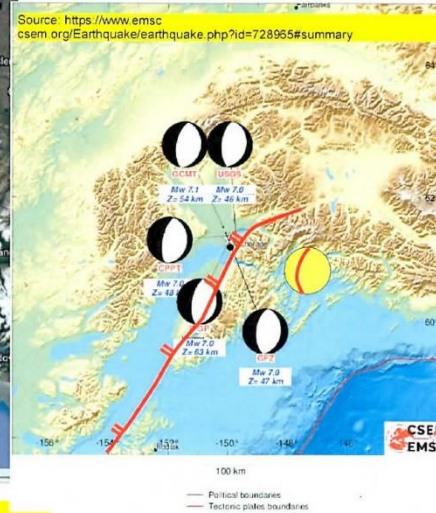
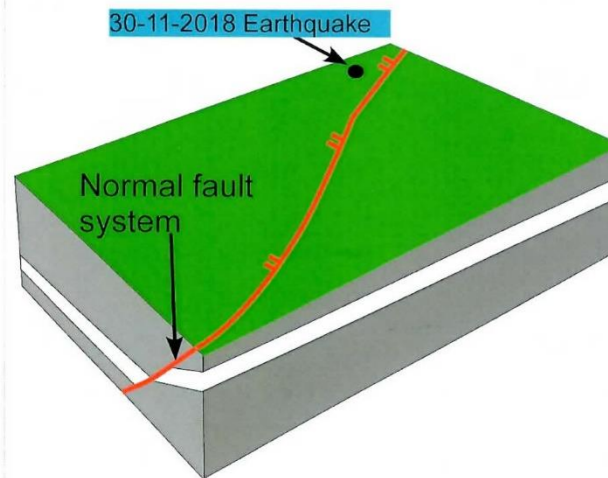
IRIS Earthquake Browser

The Mw 7.0 Earthquake of 30th Nov. 2018 seems to have ruptured a normal fault system at a depth of ~31 km. The cartoon on left is my initial interpretation of the existence of such a fault system in Alaska. It is based on the topographic expression of fault scarps that are visible on the satellite imagery. The ~NW dipping fault plane is consistent with the fault plane solutions (FPS) shown above.
