M7.1 Anchorage, Alaska Earthquake Reconnaissance Results

Structural and Nonstructural Damage

Wael M. Hassan, Ph.D., S.E.

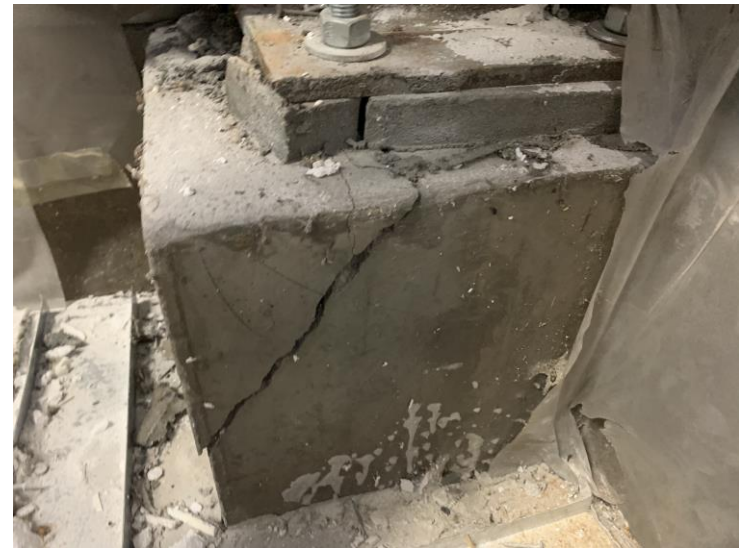
Brace Foundation Failure

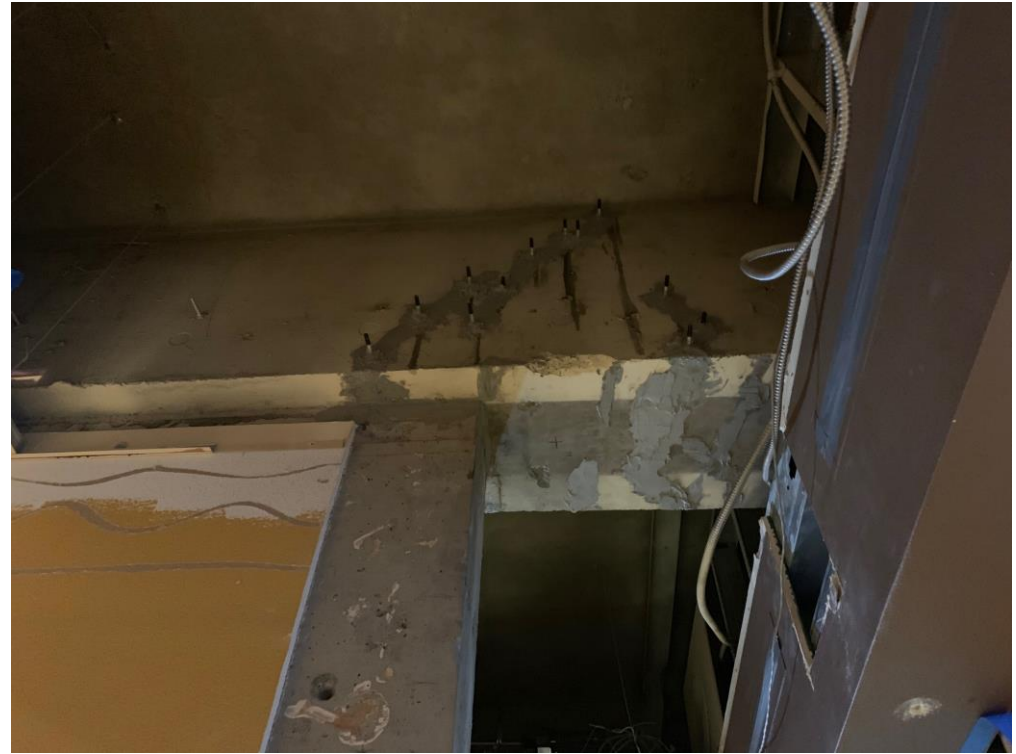
Concrete girder shear cracking
Aftershocks effect

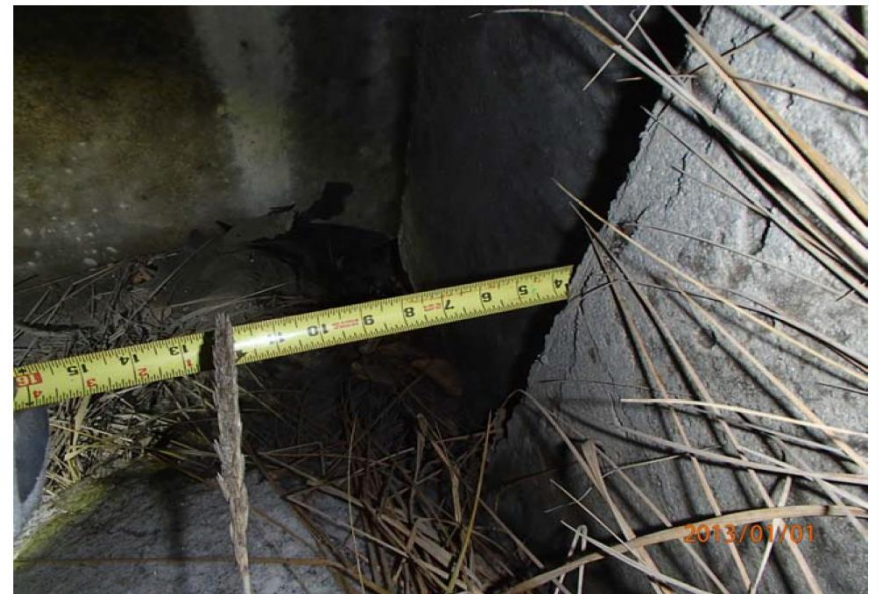
Longitudinal

Bridge Displacement
