## Vulnerability of Some Sitka School District Schools to Earthquake Damage Based on Rapid Visual Screening

June 15, 2018

Prepared for: Sitka School District and  
Alaska Seismic Hazards Safety Commission  
Administered by: The Earthquake Engineering Research Institute  
Funded by: Federal Emergency Management Agency

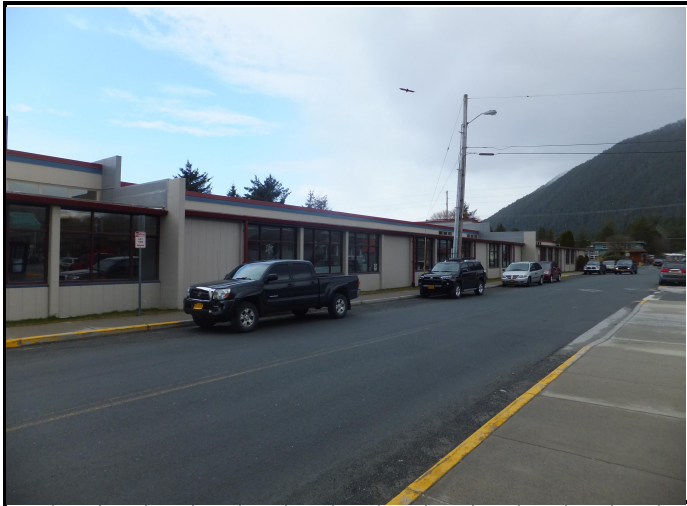
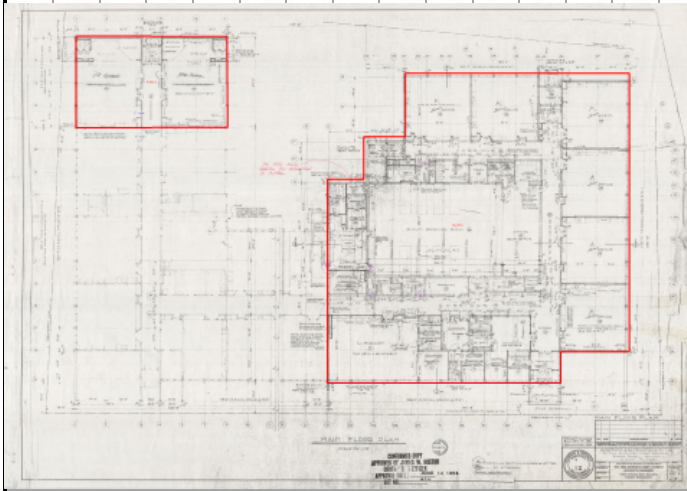
Building Name: **Baranof Elementary School, 1954 Addition**

Irregularities: ☒ Vertical (type/severity) **Moderate: split level**  
☒ Plan (type) **Reentrant corners**

**0.3**

Detailed Structural Evaluation Required?  
☐ Yes, unknown FEMA building type or other building  
☒ Yes, score less than cut-off  
☐ Yes, other hazards present  
☐ No  
Detailed Nonstructural Evaluation Recommended? (check one)  
☐ Yes, nonstructural hazards identified that should be evaluated  
☐ No, nonstructural hazards exist that may require mitigation, but a detailed evaluation is not necessary  
☐ No, no nonstructural hazards identified ☐ DNK

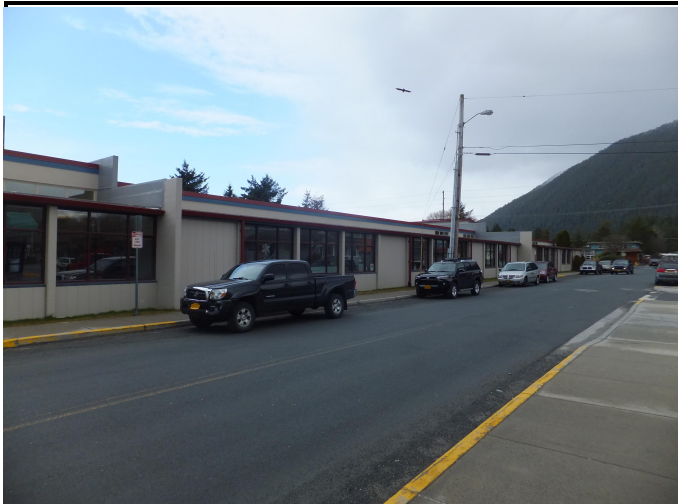
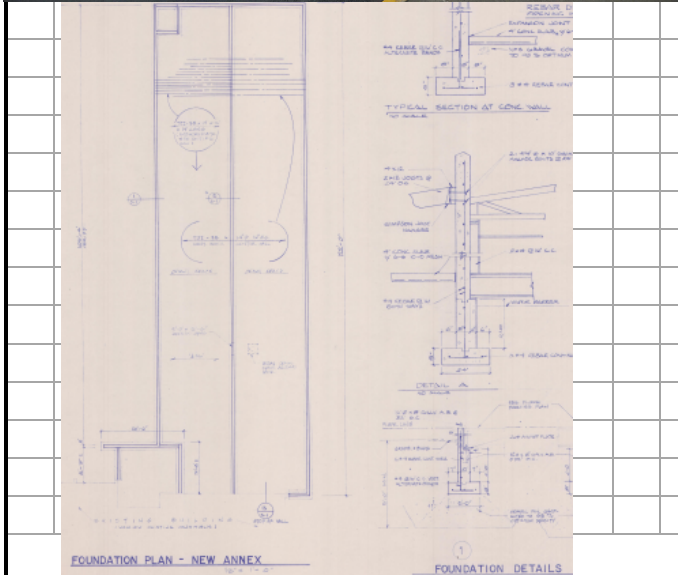
Building Name: **Baranof Elementary School, 1982 Addition**

0.8

Detailed Structural Evaluation Required?  
☐ Yes, unknown FEMA building type or other building  
☒ Yes, score less than cut-off  
☐ Yes, other hazards present  
☐ No  
Detailed Nonstructural Evaluation Recommended? (check one)  
☐ Yes, nonstructural hazards identified that should be evaluated  
☐ No, nonstructural hazards exist that may require mitigation, but a detailed evaluation is not necessary  
☐ No, no nonstructural hazards identified ☐ DNK

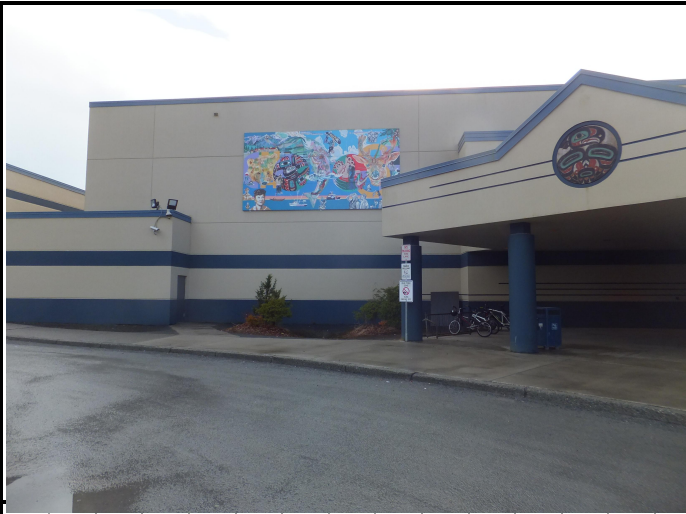
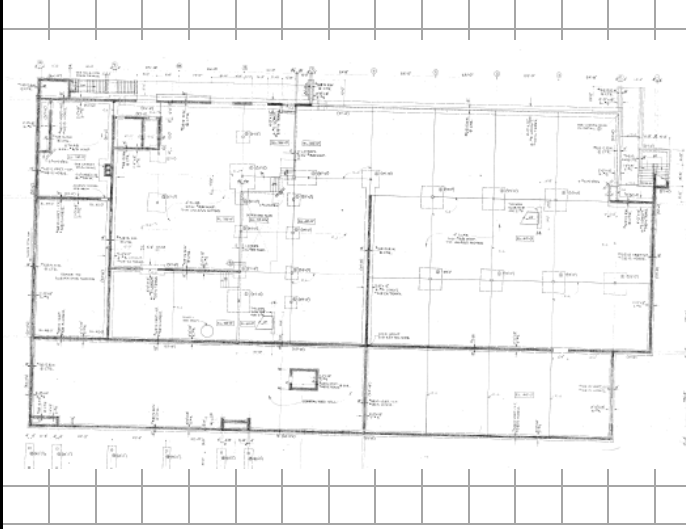
Address: **601 Halibut Point Rd**  
**Sitka, AK** Zip: **99835**

Adjacency: ☒ Pounding ☐ Falling Hazards from Taller Adjacent Building

0.8

Are There Hazards That Trigger A Detailed Structural Evaluation?  
☒ Pounding potential (unless  $S_{L2} >$  cut-off, if known)  
☐ Falling hazards from taller adjacent building  
☐ Geologic hazards or Soil Type F  
☐ Significant damage/deterioration to the structural system

☐ Yes, unknown FEMA building type or other building  
☒ Yes, score less than cut-off  
☒ Yes, other hazards present  
☐ No
