Alaska Department of Transportation & Public Facilities

Division of Facilities Services November 30, 2018 Earthquake Response

Matt Tanaka, Christopher Hodgin, Colleen Gould, Stephanie Kruse

May 2019

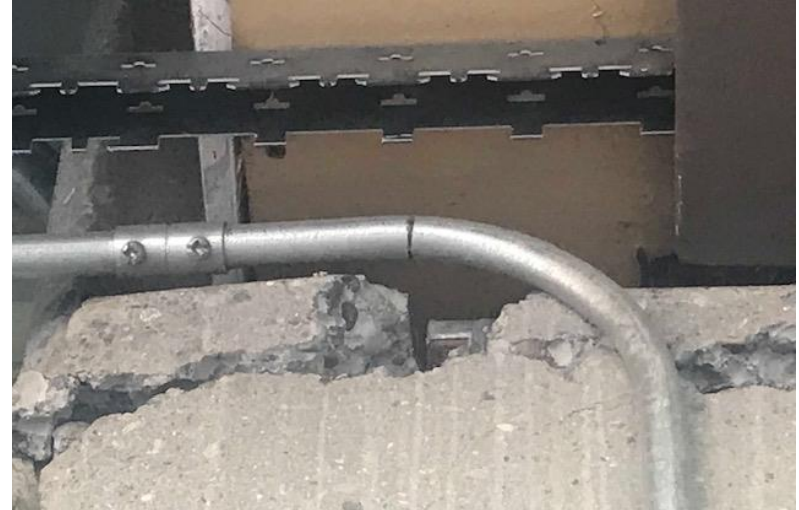
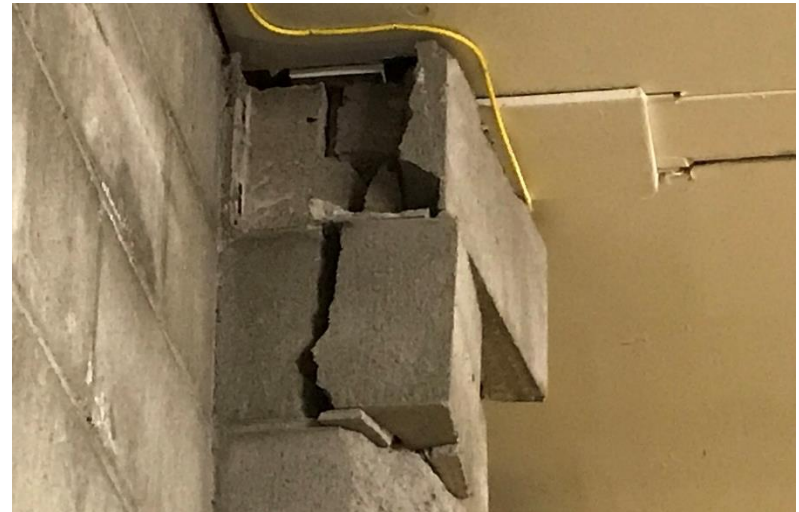
CMU damage at Wasilla Police Station (Above)
and at Whitney Road Warehouse (Below)
