## Vulnerability of Some Fairbanks North Star Borough Schools to Earthquake Damage Based on Rapid Visual Screening

June 15, 2017

Prepared for: Fairbanks North Star Borough School District and  
 Alaska Seismic Hazards Safety Commission  
 Administered by: The Earthquake Engineering Research Institute  
 Funded by: Federal Emergency Management Agency

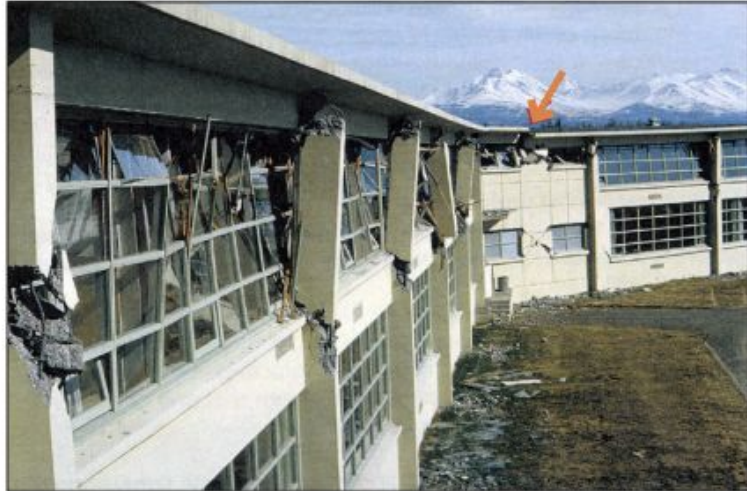
*Concrete column failure, West High School, Anchorage, AK  
After 1964 Great Alaska Earthquake*

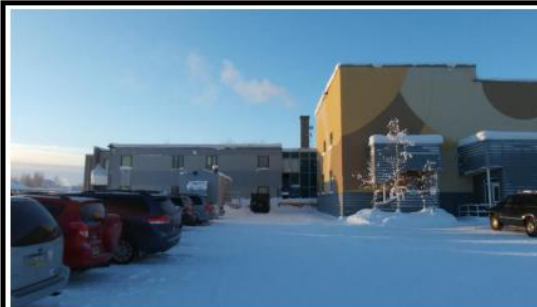
Other Identifiers:  
 Building Name: **Barnette Elementary School 1960 Original**  
 Use: **school**

Adjacency: ☒ Pounding ☐ Falling Hazards from Taller Adjacent Building

Exterior Falling Hazards: ☒ Unbraced Chimneys ☐ Heavy Cladding or Heavy Veneer  
☐ Parapets ☐ Appendages  
☐ Other: \_\_\_\_\_

☒ Pounding potential (unless  $S_{L2} >$  cut-off, if known)  
☐ Falling hazards from taller adjacent building  
☐ Geologic hazards or Soil Type F  
☐ Significant damage/deterioration to the structural system

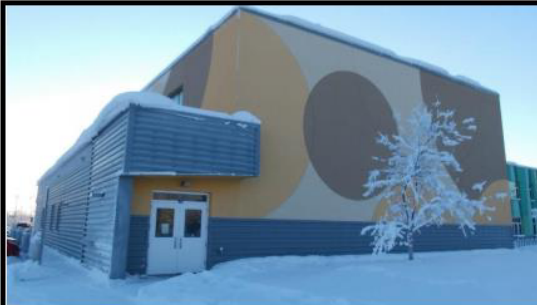
Other Identifiers:  
Building Name: **Barnette Elementary School 1974 Addition**  
Use: **school**

Irregularities: ☐ Vertical (type/severity)  
☒ Plan (type) **Reentrant corner**

COMMENTS:  
**Addition forms reentrant corner where it connects to original building's shear wall for lateral and vertical support.**

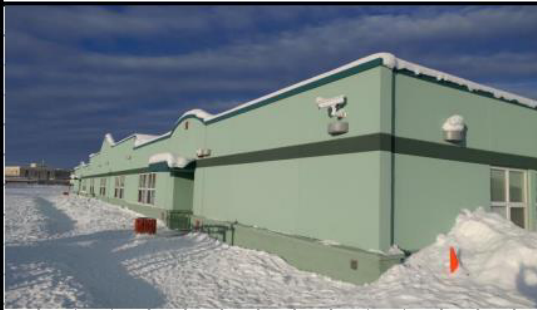
Drawings not available, but  
appears to be similar  
construction to 1957 addition

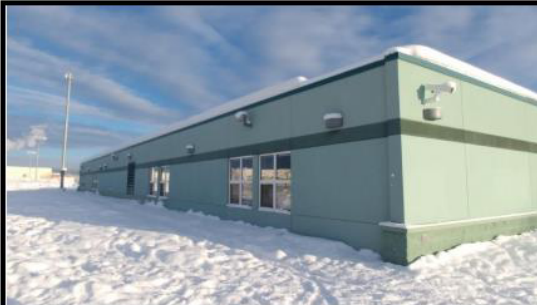
Other Identifiers:  
Building Name: **Hunter Elementary School 1974 Addition**  
Use: **school**

Addition is nested within earlier additions but separated from them with a 1/2" expansion joint at the foundation. A similar joint is shown on sheet G1 at the wood roof though without a dimension, and no lateral system for the steel frame is shown. Therefore, it is likely that this addition is tied to the 1958 and 1959 additions for lateral loads.
