M7.1 Anchorage, Alaska Earthquake Reconnaissance Results

Structural and Nonstructural Damage

Wael M. Hassan, Ph.D., S.E.

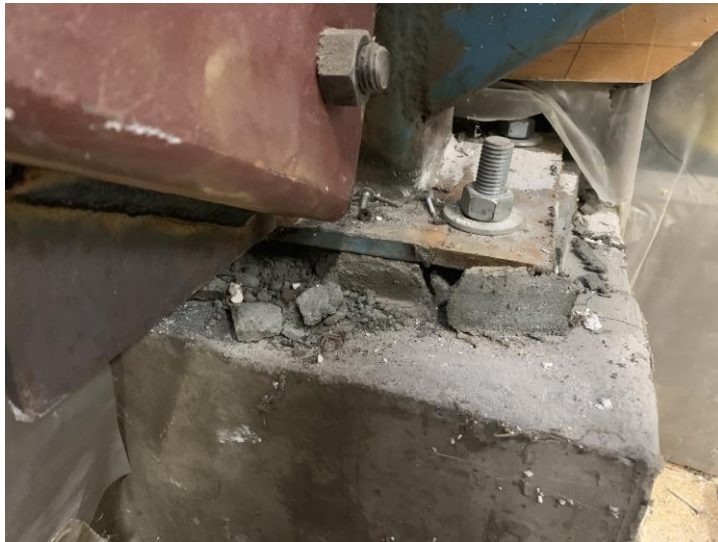
Brace Foundation Failure

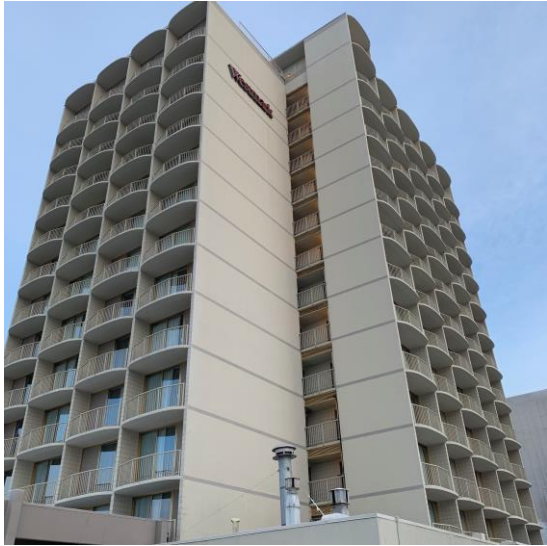
High-Rises (Anchorage)

Concrete girder shear cracking
Aftershocks effect

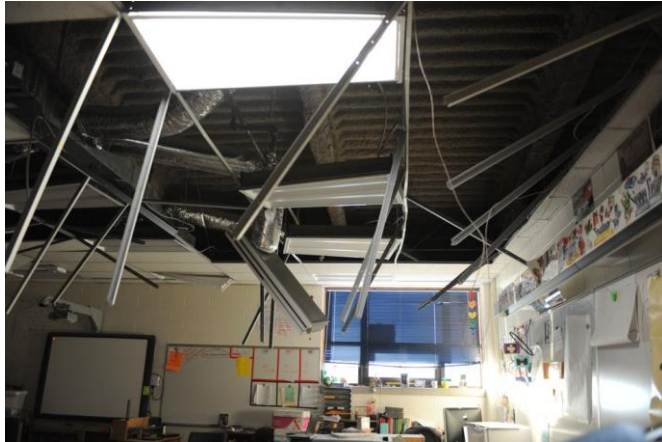
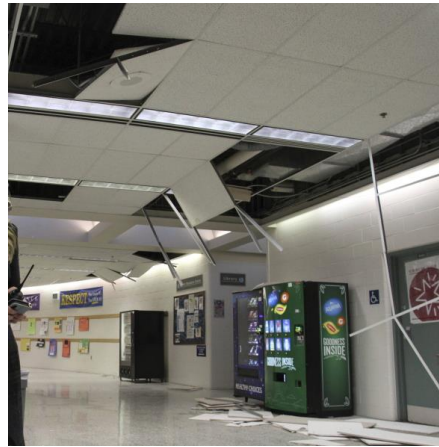
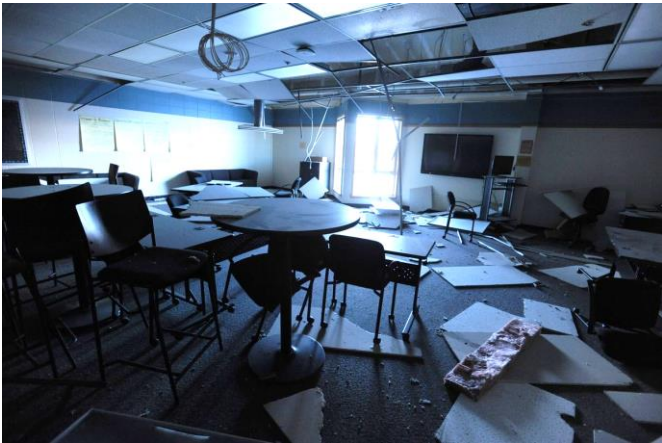
Anchorage Schools

- 85 of 97 schools had sort of damage
- Only two schools had moderate to severe structural damage (CMU); still shut down
- 15 schools received thorough structural eval due to minor structural damage, 7 of which in Eagle River
- Schools reopened Dec 10
- Estimated PGA 0.2-0.3g

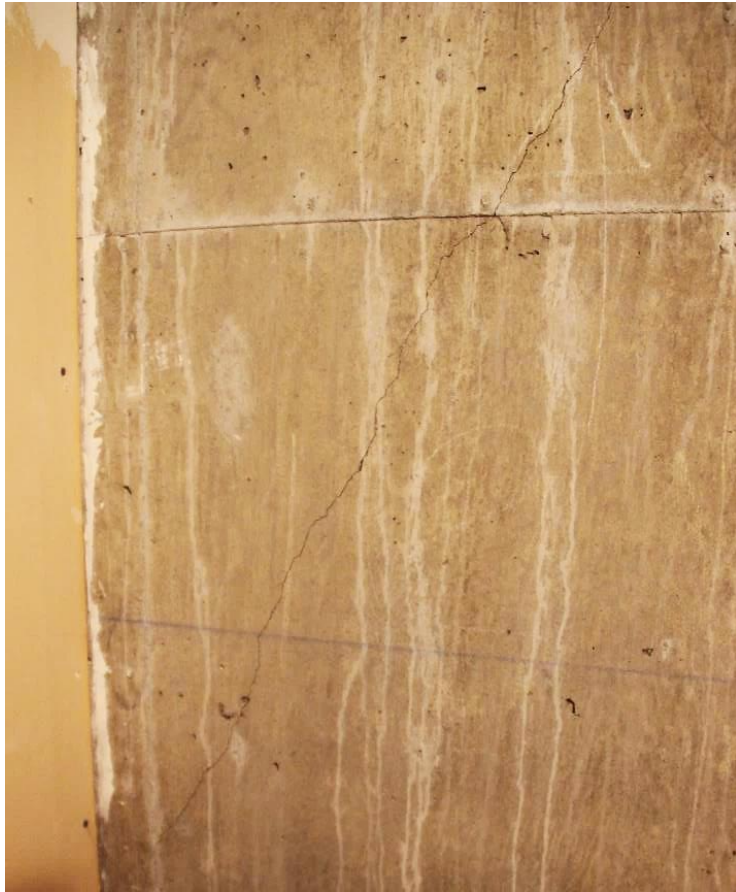
Mat-Su Valley Schools

- Most of 50 schools had sort of damage
- Only two schools had moderate to severe structural damage (CMU); still shut down
- 11 schools suffered minor structural damage
- Schools reopened Dec 2 thru Dec 5
- Estimated PGA 0.2-0.3g

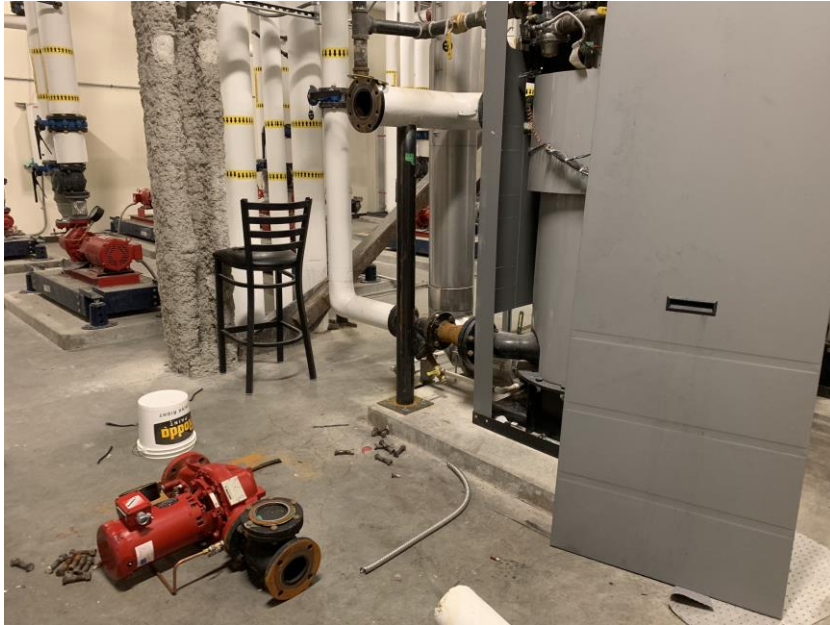
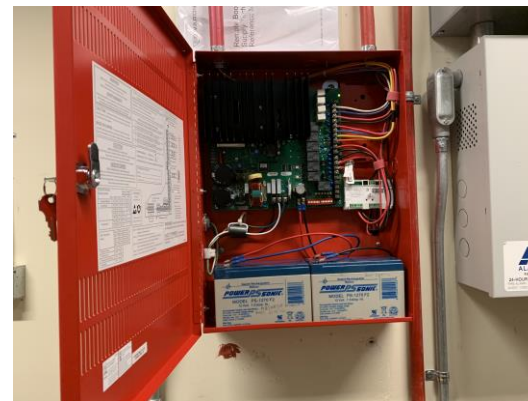
Hospitals and Healthcare Facilities

Nonstructural Damage

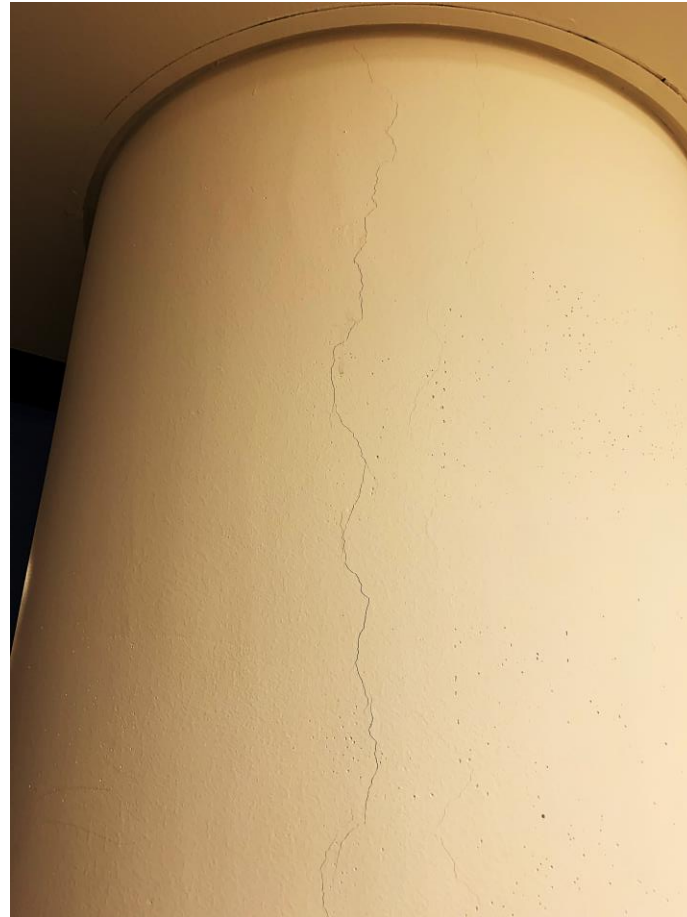
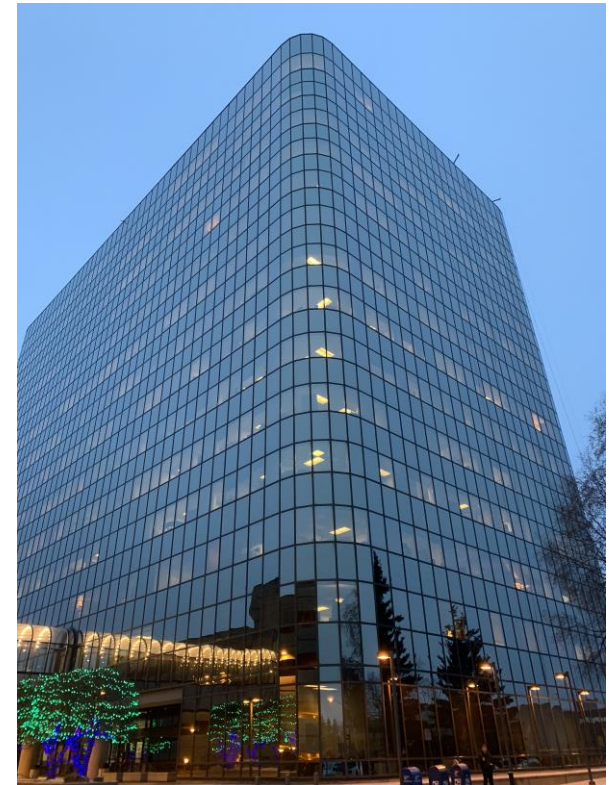
Frontier Building (Concrete Framing) 1985

PGA 0.193g
PRA 0.223g

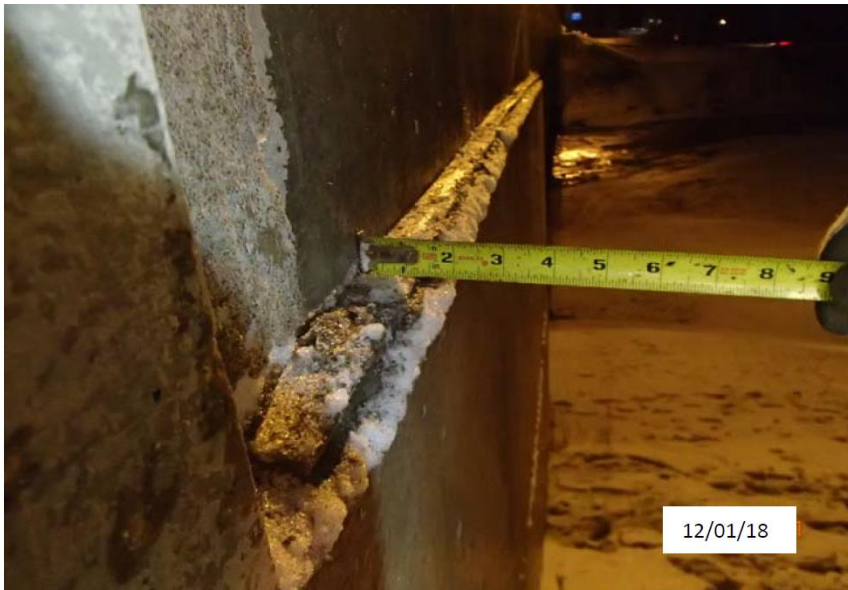
Bridge Displacement

Transverse
